Fieldservice Bulletin

Order-No.: DD+DIS119.00E

Field Service Bulletin Nr. 9 for ADC Solo Type 5155

Suction cups don´t release IP

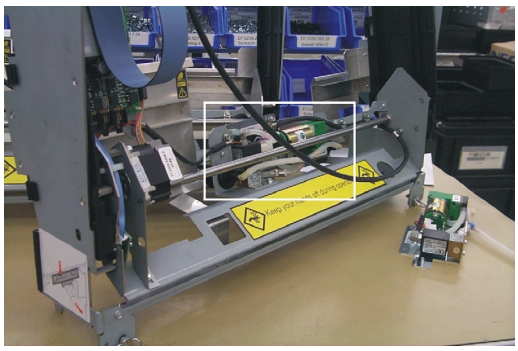
Figure 1

Dust protection of solenoid valve has not been removed.

1. Open the right side panel.
2. Examine the solenoid valve of the vacuum pump in the IP-transport unit.

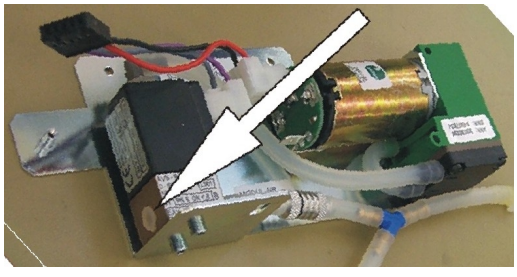
Figure 2

3. If the dust protection (arrow) is still on the solenoid valve, use a firm solid tool (e.g. screwdriver) to remove the plastic plug from the solenoid valve of the vacuum pump.

The dust protection can be removed permanently. It is not needed during operation.
